# **Investigation of Road Accident FIR Number 64, dated 03<sup>rd</sup> June, 2014 at the Signalised Intersection of Tughlak Road - Safdarjung Road - Aurobindo Marg and Prithiviraj Road**

# Investigation of Road Accident FIR Number 64, dated 03<sup>rd</sup> June, 2014 at the Signalised Intersection of Tughlak Road - Safdarjung Road - Aurobindo Marg and Prithiviraj Road

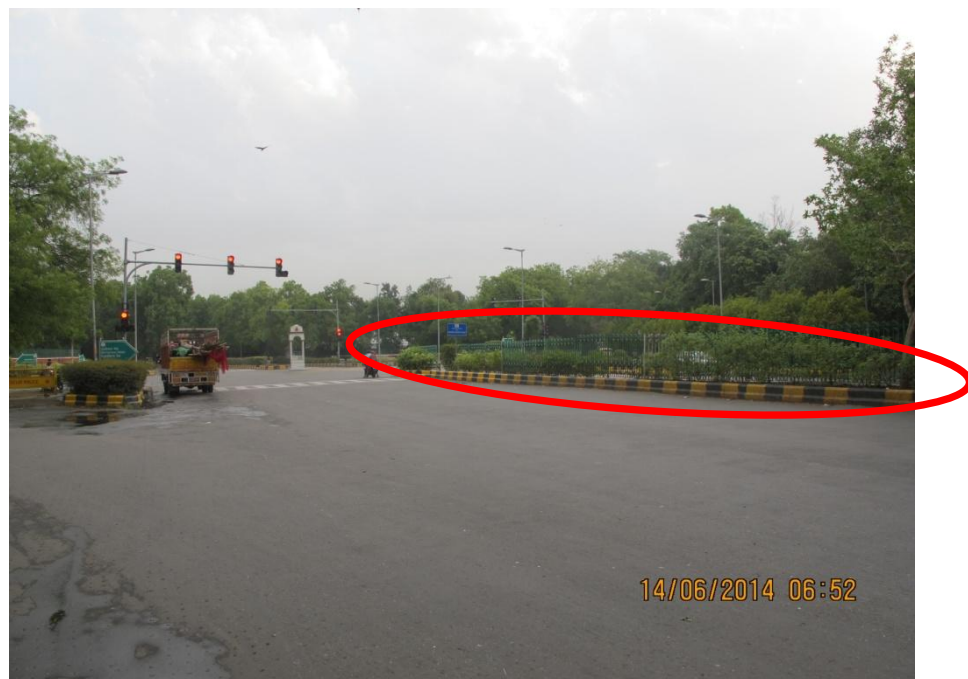
**Figure 2.4: Overgrown Suburbs at the Median Portion on the Aurobindo Marg Approach obscuring the visibility of the traffic emanating from Prithviraj Road Approach until it reaches the mouth of the intersection (a)**  
*(i.e. Oblique Angle of meeting of the Prithviraj Road Approach)*

- < All the intersecting arms are not meeting at right (Angles 3.) and moreover, there is complete absence of the minimum required Intersection Sight Distance (ISD) especially on the Prithviraj Road Approach due to the overgrown trees on the shoulder side and more importantly poor geometrics at the junction approach (i.e. Prithviraj Road Approach intersection at oblique angle instead of a conventional right angle aggravating the ISD problems. Similarly, the overgrown suburbs at the median portion on the Aurobindo Marg approach is again obscuring the visibility terms of approaching vehicles to the intersection from Prithviraj Road approach and vice versa which is again serious use of concern

- First and foremost, it is essential to go in for the immediate pruning of the over grown suburbs and protruding branches of the big trees on to the main intersection on all the intersection approaches which will help in improving the sight distance at this intersection to a large extent.**

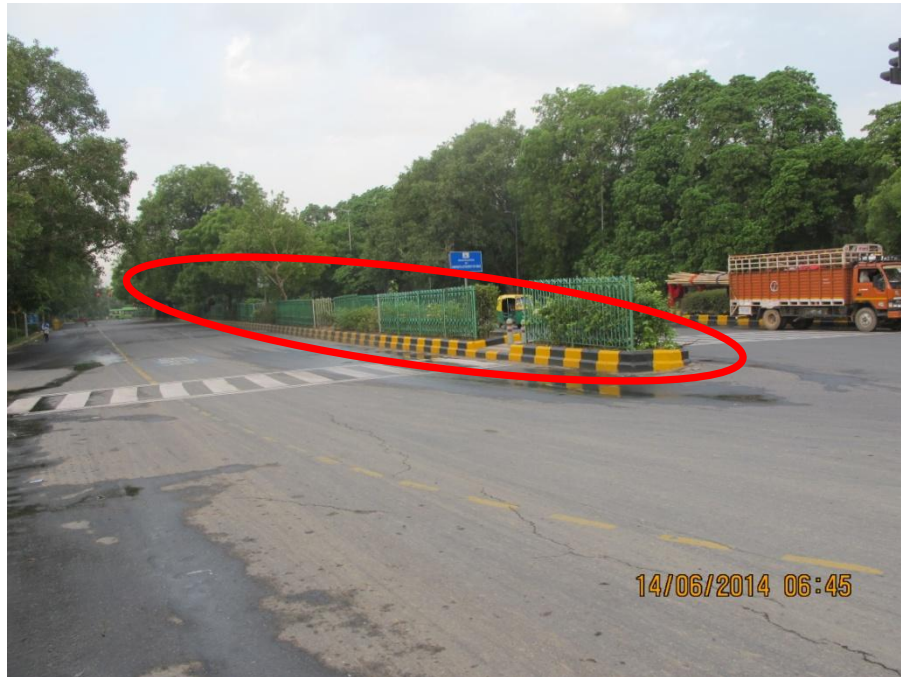
**Figure 2.5: : Overgrown Suburbs at the Median Portion on the Aurobindo Marg Approach obscuring the visibility of the traffic emanating from Prithiviraj Road Approach until it reaches the mouth of the intersection (b)**
